**University of Missouri  
For  
The Curators of the University of Missouri  
MU Project Number CP253191  
Advertisement Date: January 8, 2026  
General Site - Electric & Steam Manholes Concrete Repairs**

**Columbia, Boone County, Missouri**

DRAWING INCLUDES:
COVER SHEET
DESIGNED: GLL
DRAWN: TGC
PROJECT NO.: 180016
MU PROJECT NO.: CP253191
SHEET: COVER

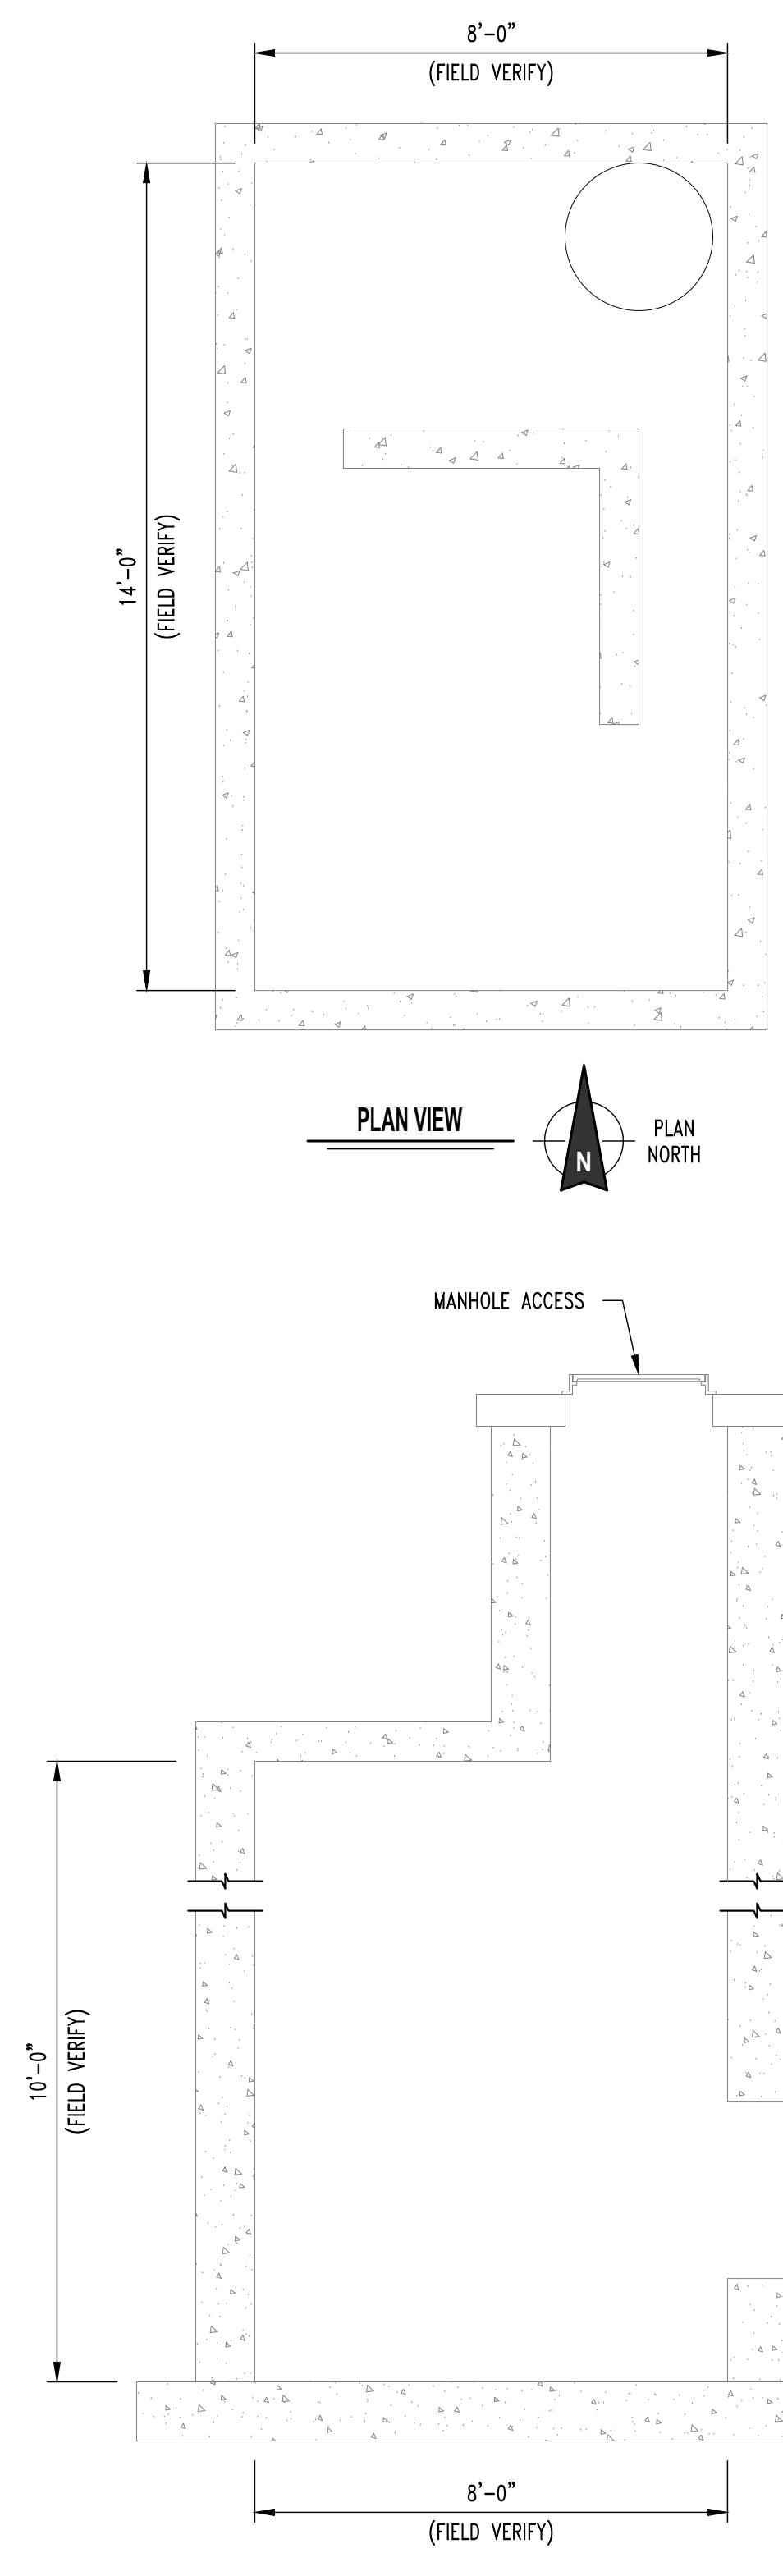
SMH #414 - SOUTH COLLEGE AVE.  
(PHOTO #1)

① CONCRETE SPALLING SOUTH SIDE OF EAST/WEST ANCHOR WALL @ WEST END, SEE NOTE #1.  
② OWNER TO REMOVE PRIOR TO REPAIRS.

③ CONCRETE SPALLING SOUTH WALL OF MANHOLE, SEE NOTE #2.

④ CONCRETE SPALLING WEST SIDE OF NORTH/SOUTH ANCHOR WALL @ SOUTH END, SEE NOTE #3.

⑤ CONCRETE SPALLING UNDER NORTH CHASE, SEE NOTE #4.

- 24"x36" CONCRETE REPAIR ON ANCHOR WALL (EXPECT REPAIR #3).
- SOUTH WALL REPAIR SPALL, 3'-0"x4'-0" AREA (EXPECT REPAIR #2).
- REBAR ANCHORAGE CONCRETE REPAIR, 1'-0"x2"x0" AREA (EXPECT REPAIR #2).
- 36"x36" CONCRETE REPAIR ON NORTH WALL (EXPECT REPAIR #2).

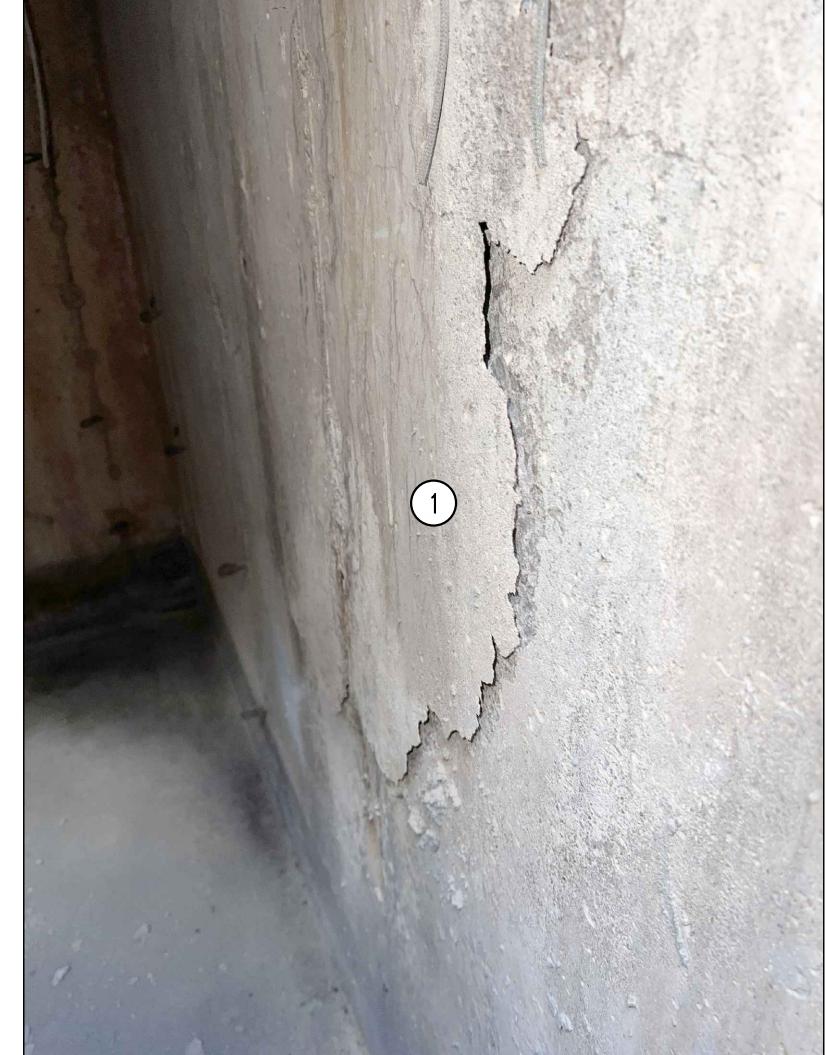
SMH #415 - EAST OF AG ENGINEERING  
(PHOTO #1)

1. EAST WALL CONCRETE SPALLING 48" x 48" (EXPECT REPAIR #2).
2. FULL LID CONCRETE SPALLING & PRIOR PATCHING FAILURE (EXPECT REPAIR #2).
3. SOUTH WALL CONCRETE SPALLING 48" x 48" (EXPECT REPAIR #2).
4. WEST CONCRETE ANCHOR SPALLING 30" x 48" (EXPECT REPAIR #3). (NOTE: ONLY REMOVE LOOSE MATERIAL & PATCH BACK)
5. EAST CONCRETE ANCHOR SPALLING 30" x 48" (EXPECT REPAIR #3). (NOTE: ONLY REMOVE LOOSE MATERIAL & PATCH BACK)
6. NORTH WALL CONCRETE SPALLING 36" x 36" (EXPECT REPAIR #2).

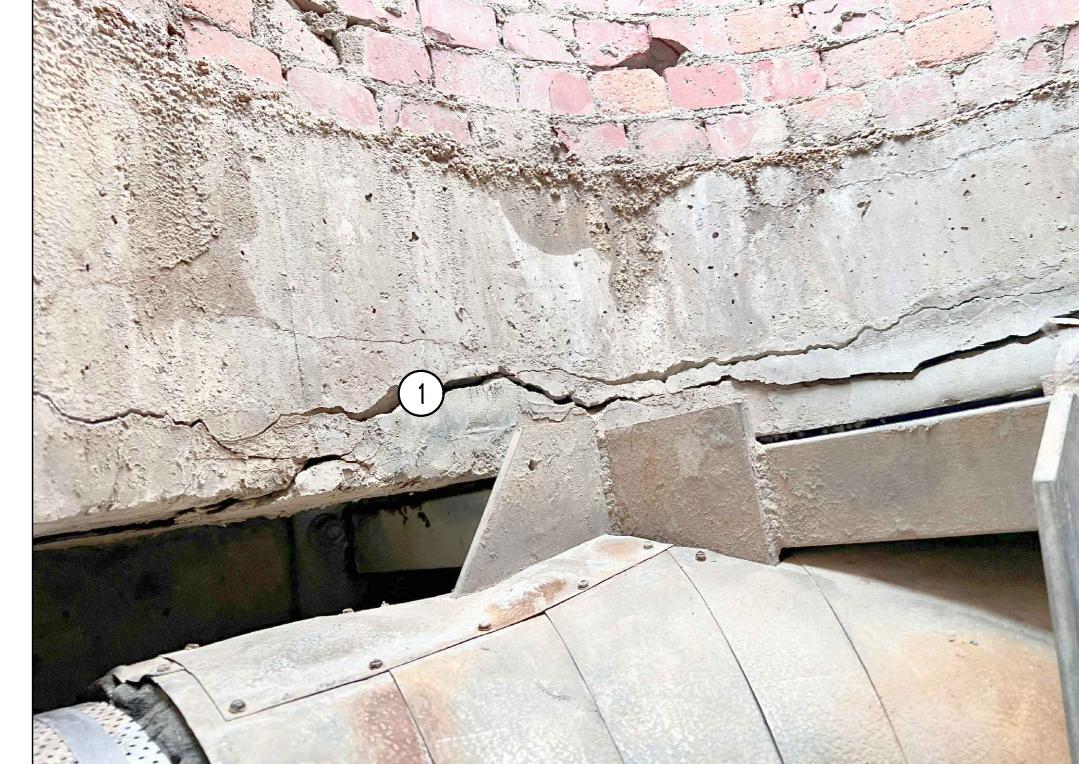
SMH #504 - WEST SIDE OF NORTH PROVIDENCE TUNNEL  
(PHOTO #1)

① LID CONCRETE SPALLING. SEE NOTE #1.

1. ROOF CONCRETE SPALL 5'-0"x9'-0". EXPECT REPAIR #3.

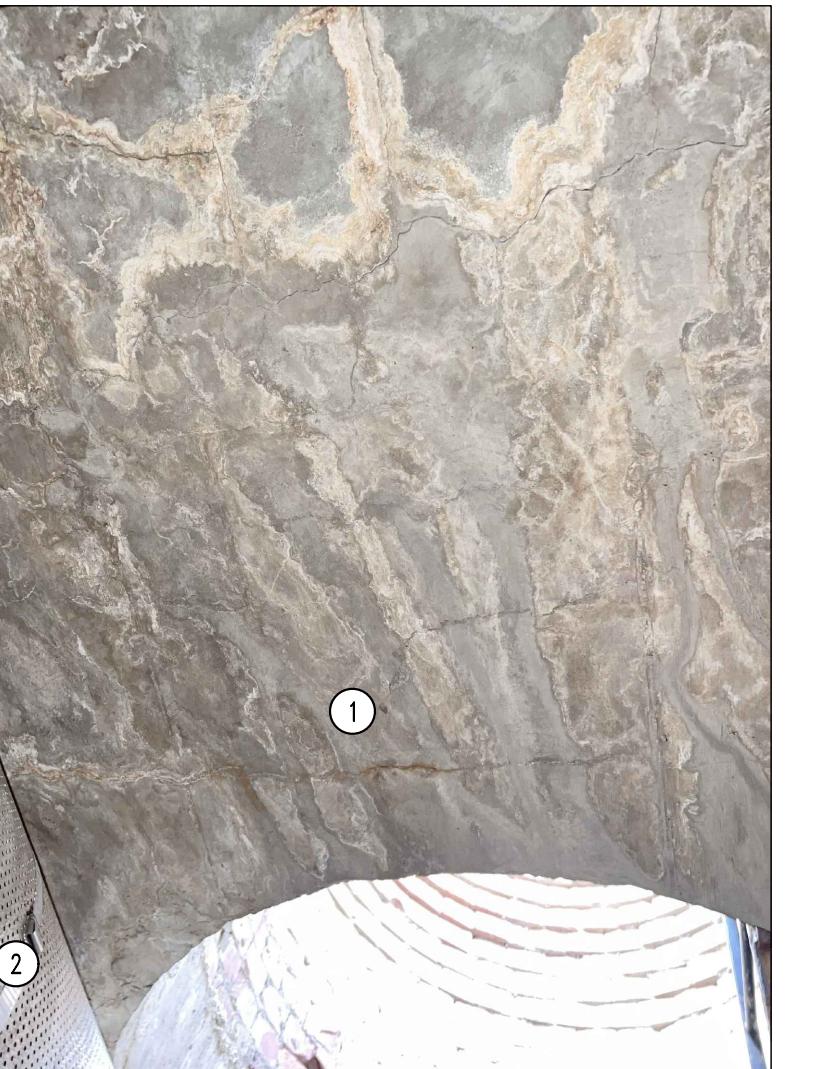
SMH #504 - WEST SIDE OF NORTH PROVIDENCE TUNNEL  
(PHOTO #3)

① LID EAST SIDE OF RISER CONCRETE SPALL. SEE NOTE #1.  
② PROTECT STEAM PIPE FROM FALLING DEBRIS.
