**University of Missouri  
For  
The Curators of the University of Missouri  
MU Project Number CP253191  
Advertisement Date: January 8, 2026  
General Site - Electric & Steam Manholes Concrete Repairs**

**Columbia, Boone County, Missouri**

DRAWING INCLUDES:
COVER SHEET
DESIGNED: GLL
DRAWN: TGC
PROJECT NO.: 180016
MU PROJECT NO.: CP253191
SHEET: COVER

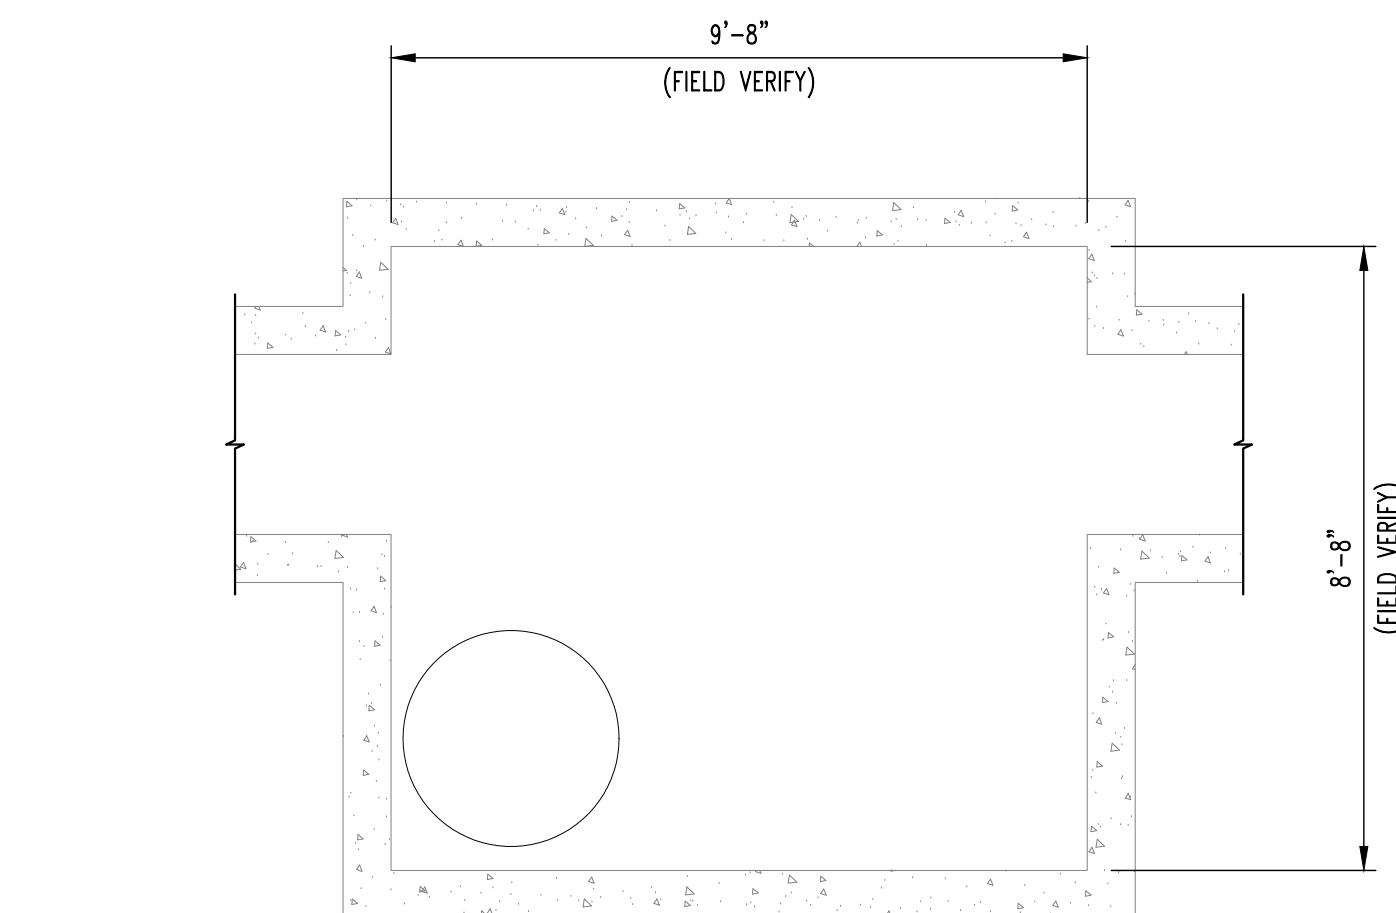
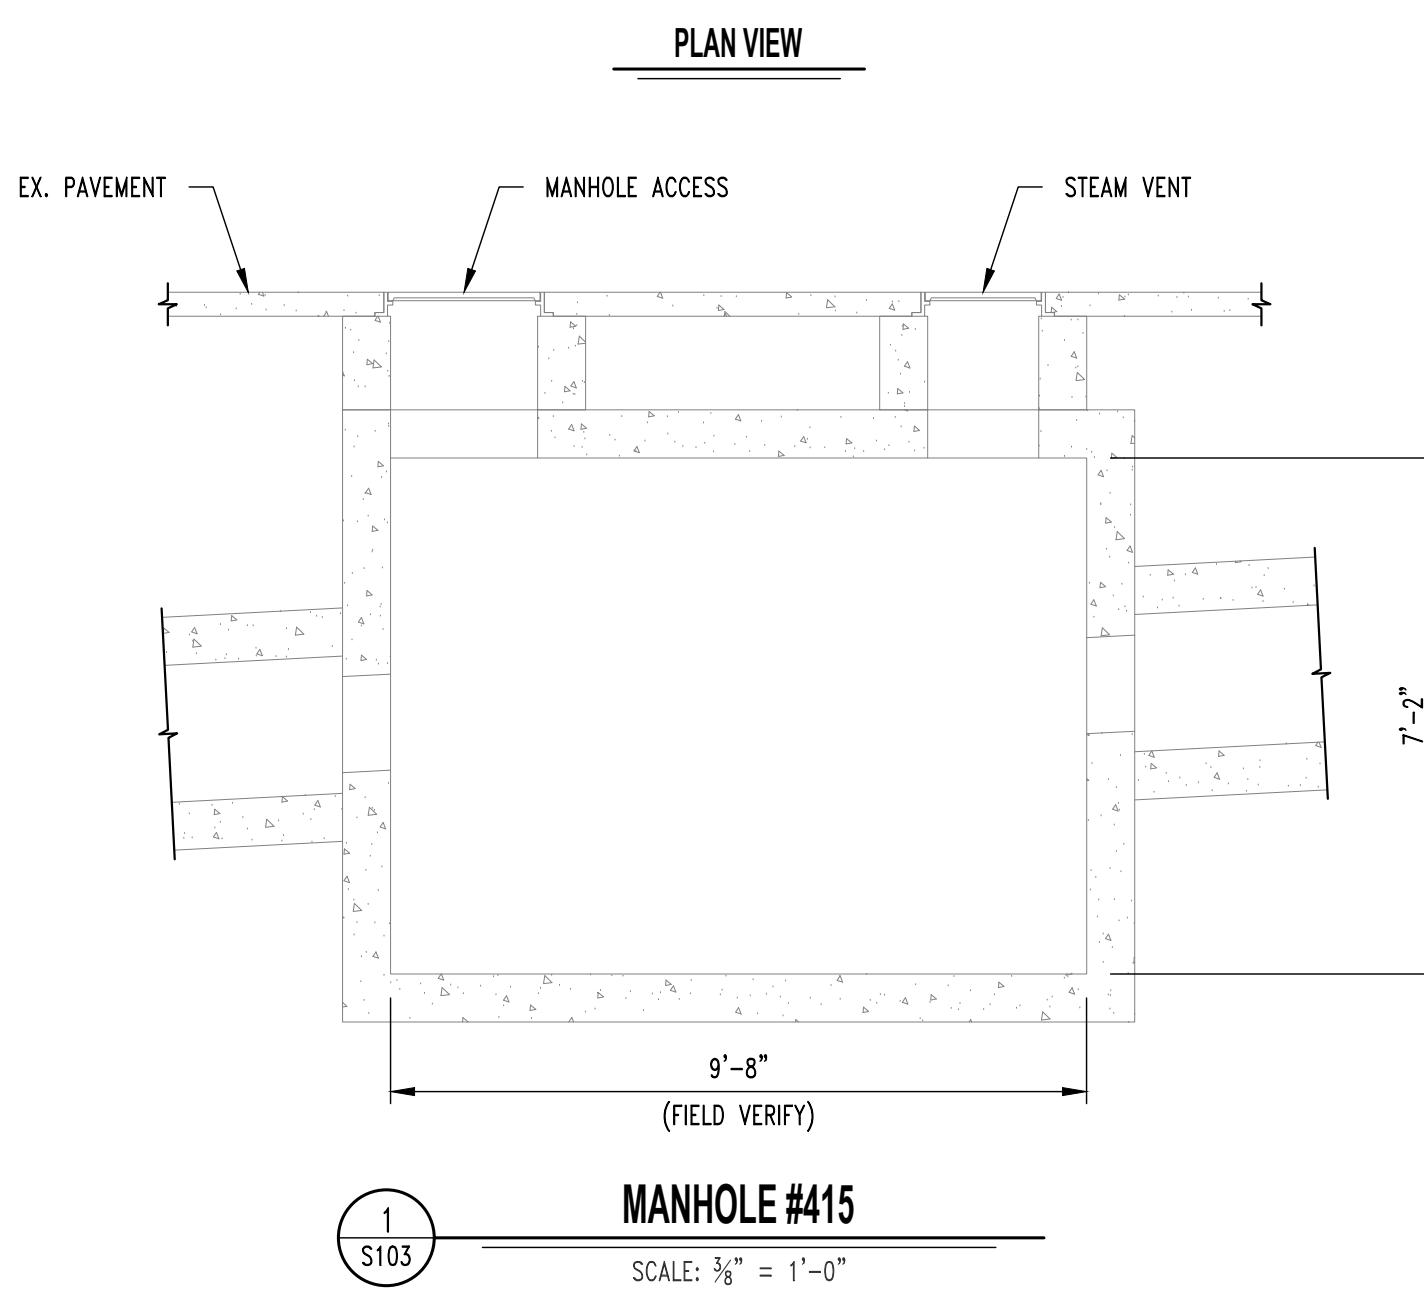
SMH #415 - EAST OF AG ENGINEERING  
(PHOTO #8)

### SMH #415 APPROXIMATE REPAIR AREAS

1. EAST WALL CONCRETE SPALLING 48" x 48" (EXPECT REPAIR #2).
2. FULL LID CONCRETE SPALLING & PRIOR PATCHING FAILURE (EXPECT REPAIR #2).
3. SOUTH WALL CONCRETE SPALLING 48" x 48" (EXPECT REPAIR #2).
4. WEST CONCRETE ANCHOR SPALLING 30" x 48" (EXPECT REPAIR #3). (NOTE: ONLY REMOVE LOOSE MATERIAL & PATCH BACK)
5. EAST CONCRETE ANCHOR SPALLING 30" x 48" (EXPECT REPAIR #3). (NOTE: ONLY REMOVE LOOSE MATERIAL & PATCH BACK)
6. NORTH WALL CONCRETE SPALLING 36" x 36" (EXPECT REPAIR #2).

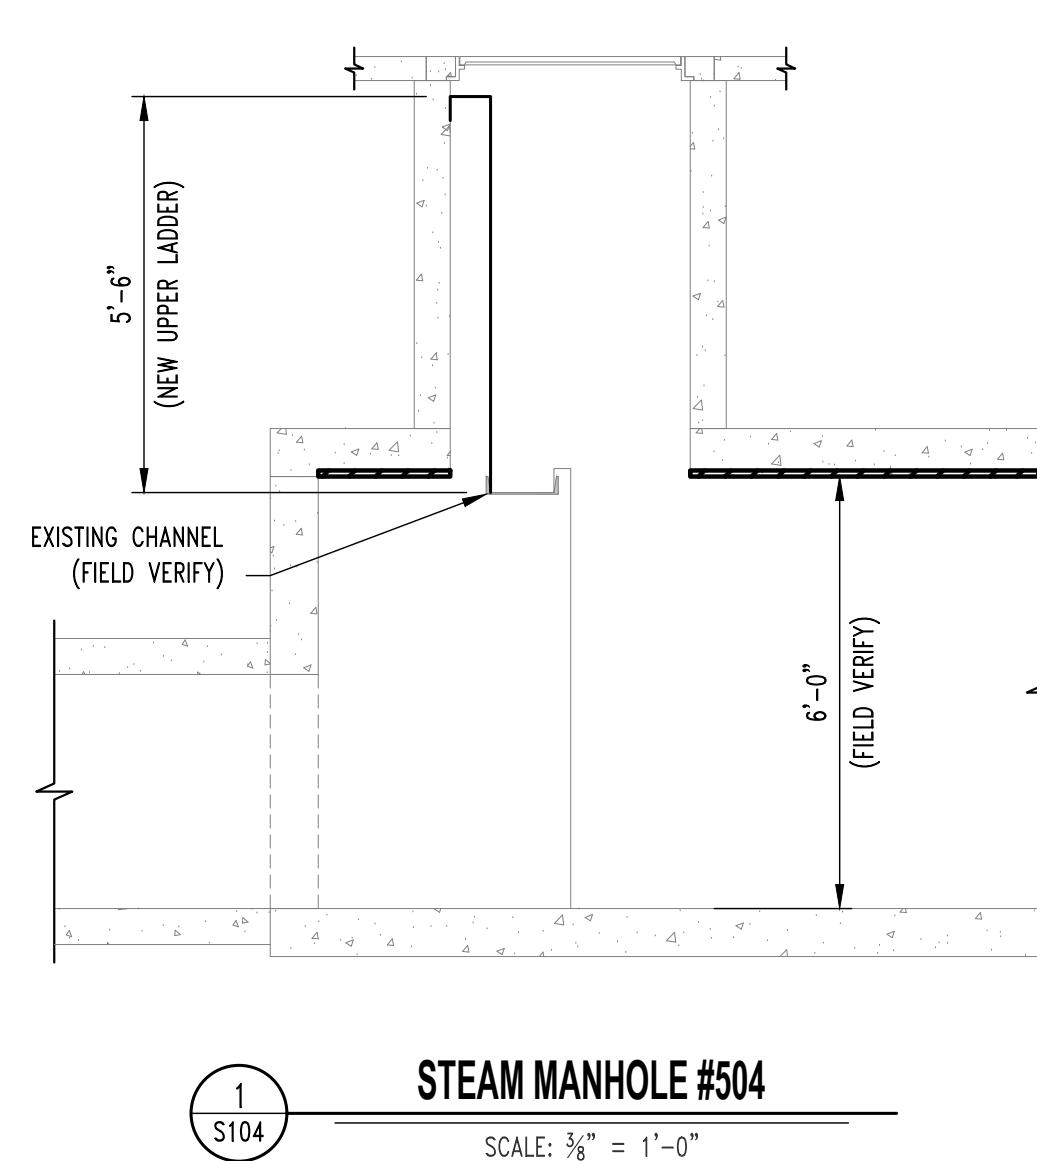
STEAM MANHOLE #504  
S104

SMH #504 APPROXIMATE REPAIR AREAS

1. ROOF CONCRETE SPALL 5'-0"x9'-0". EXPECT REPAIR #3.
